Windstorm Mitigation Report

Harbor Place at Safety Harbor Condominium

Safety Harbor, FL

As of 5/20/2021 | FPAT File# VAL2116038

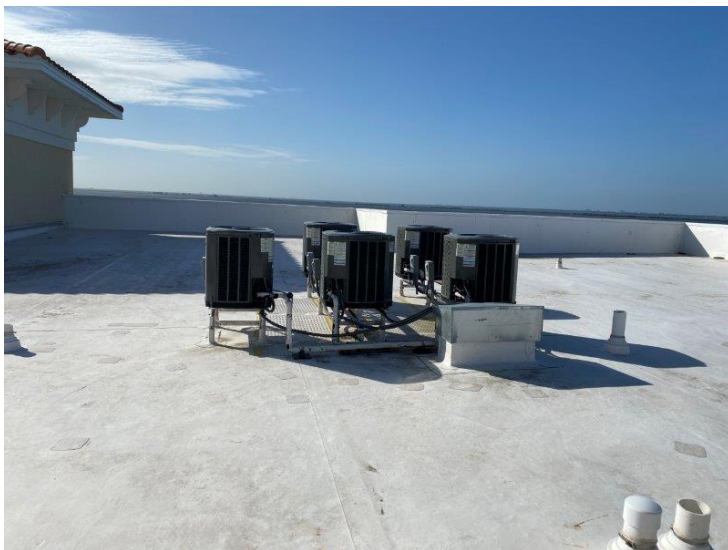
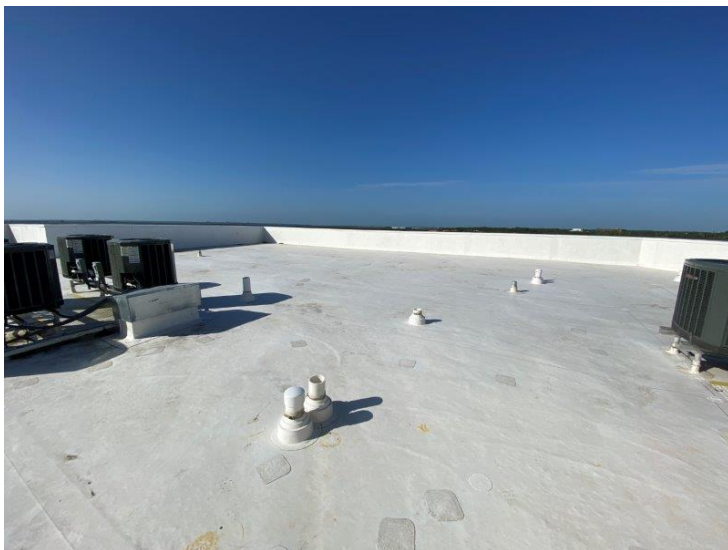
Roof Construction

- 3. Roof Deck Attachment:** **Reinforced Concrete Roof Deck**
Comments: Inspection verified a roof structure composed of cast-in-place or pre-cast structural concrete designed to be self-supporting and integrally attached to the wall / support system.

- 4. Roof to Wall Attachment:** **Structural**
Comments: Inspection verified a roof structure composed of cast-in-place or pre-cast structural concrete designed to be self-supporting and integrally attached to the wall / support system.

- 5. Roof Geometry:** **Flat Roof**
Comments: Inspection verified flat roof shape, refer to attached photographs.
- 6. SWR:** **No**
Comments: SWR does not apply to reinforced concrete roof decks.

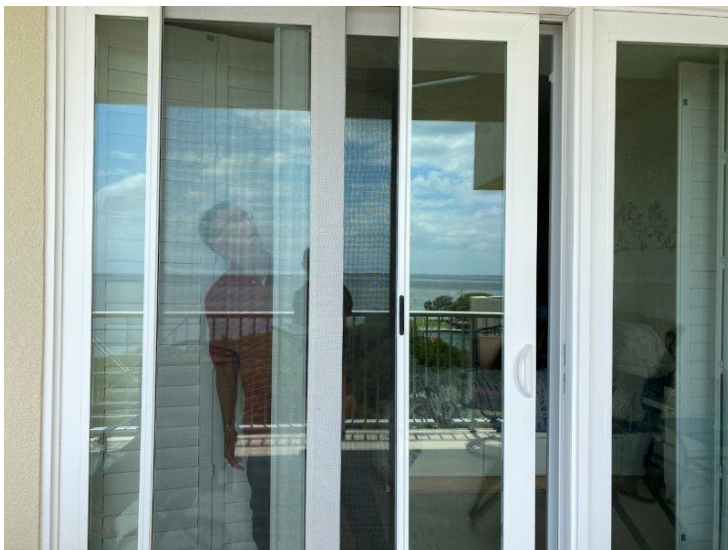
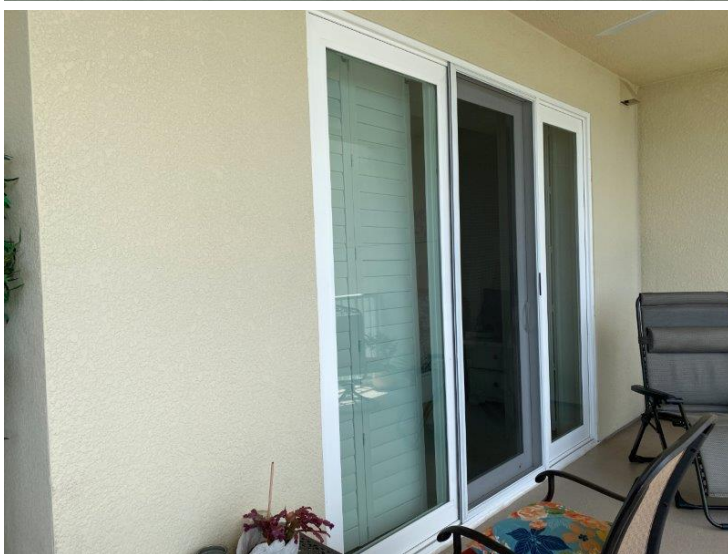
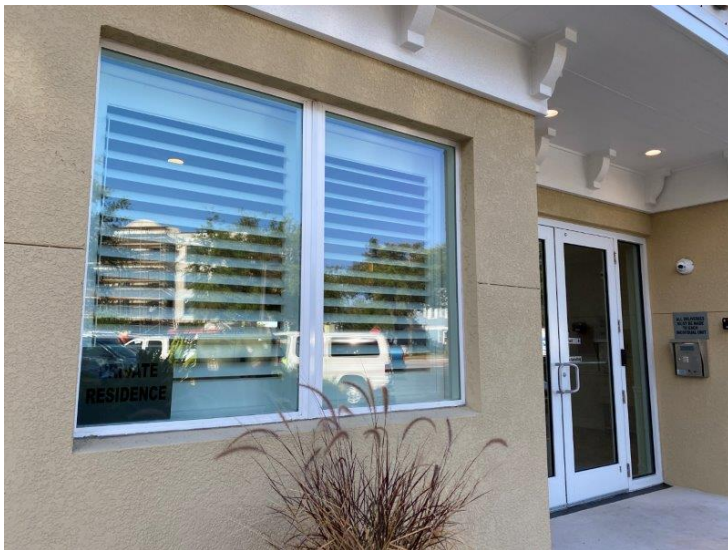
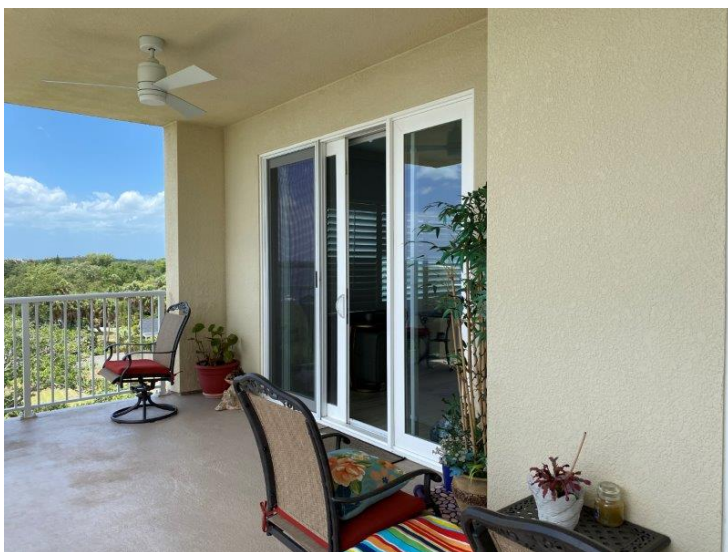
Opening Protection

- 7. Opening Protection:** **Exterior Openings Cyclic Pressure & 9-lb Large Missile**
Comments: Inspection verified all windows and sliding glass doors are protected with large missile rated glazing. See attached photographs.

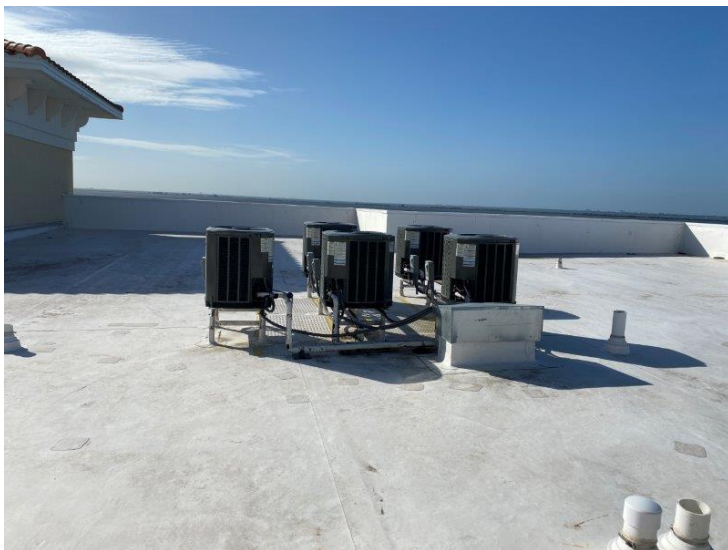
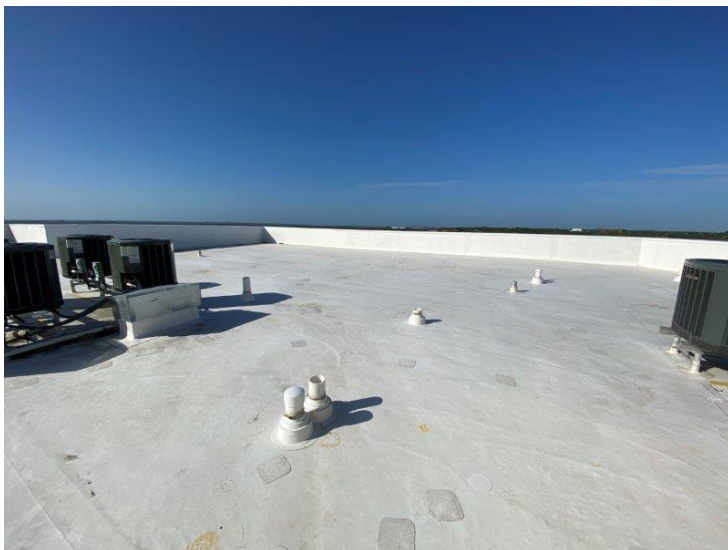
Roof Construction

- 1. Roof Covering:** **FBC Equivalent**
Comments: The roof coverings were installed with the original construction of the building in 2019 meeting the requirements of the mitigation affidavit.
- 2. Roof Deck Attachment:** **Reinforced Concrete Roof Deck**
Comments: Inspection verified a roof structure composed of cast-in-place or pre-cast structural concrete designed to be self-supporting and integrally attached to the wall / support system.
- 3. SWR:** **No**
Comments: SWR does not apply to reinforced concrete roof decks.
- 4. Opening Protection:** **Exterior Openings Cyclic Pressure & 9-lb Large Missile**
Comments: Inspection verified all windows and sliding glass doors are protected with large missile rated glazing. See attached photographs.
